ACR Guidance Document on MR Safe Practices: 2013

Key Words: MR safety; MR; MR safe practices
J. Magn. Reson. Imaging 2013;37:501–530.
 © 2013 Wiley Periodicals, Inc.

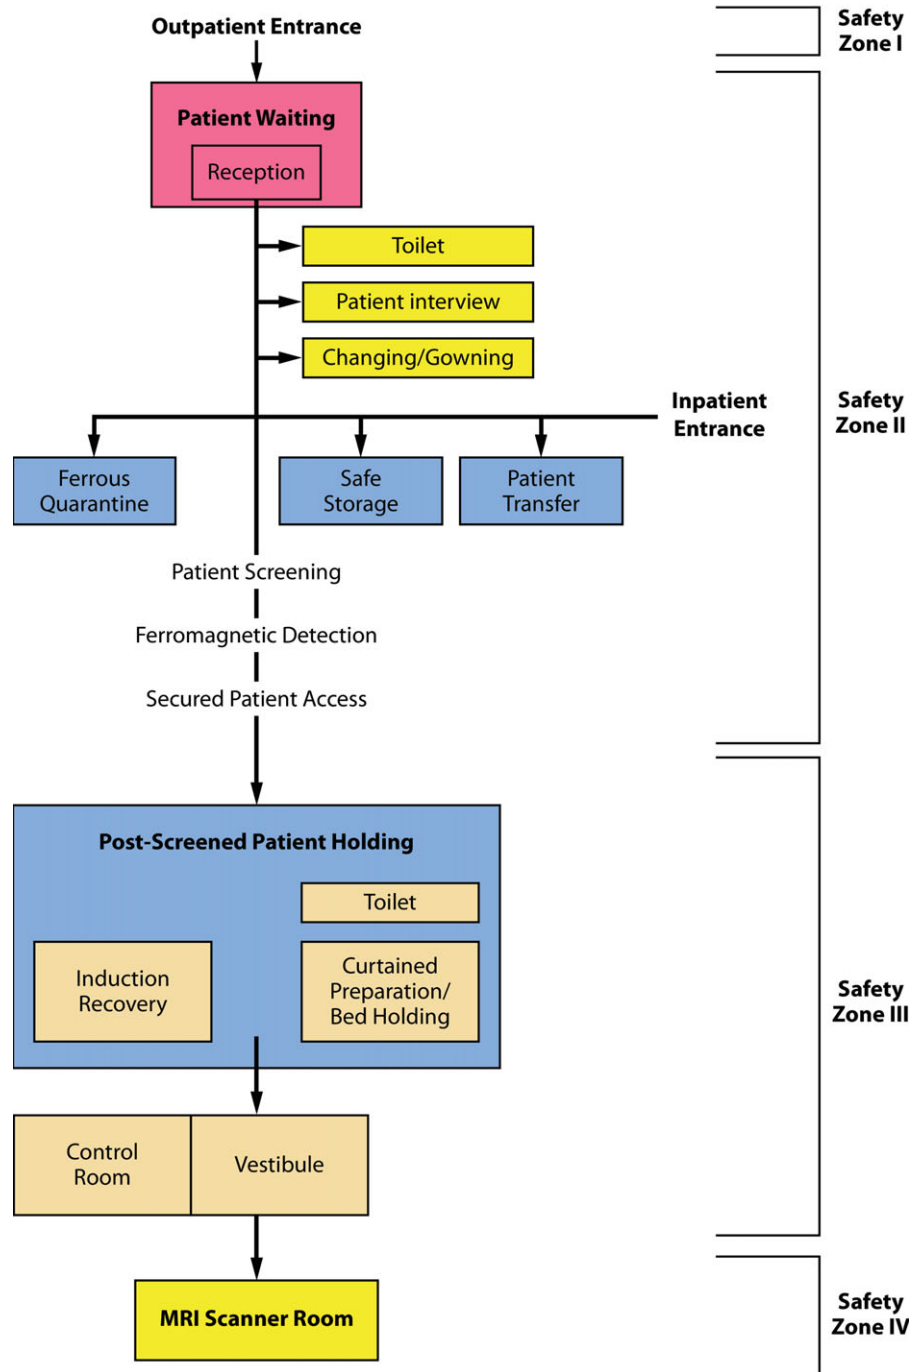
MRI Functional Diagram

Figure 1. Idealized sample floor plan illustrates site access restriction considerations. Other MR potential safety issues, such as magnet site planning related to fringe magnetic field considerations, are not meant to be include herein. See Appendix 1 for personnel and zone definitions. Note—In any zone of the facility, there should be compliance with Health Insurance Portability and Accountability Act (HIPAA) regulations in regard to privacy of patient information. However, in Zone III, there should be a privacy barrier so that unauthorized persons cannot view control panels.

Note: In any zone of the facility, there should be compliance with HIPAA regulations in regard to privacy of patient information. However, in Zone III, there should be a privacy barrier so that unauthorized persons cannot view the control panels. Please note that this diagram is an example intended for educational, illustration purposes only. The MR Functional Diagram was obtained from and modified with the permission of the “Department of Veterans Affairs Office of Construction & Facilities Management, Strategic Management Office”.

The MR site is conceptually divided into four Zones [see Fig. 1 and Appendices 1 and 3]:

- d. Zone IV: This area is synonymous with the MR scanner magnet room itself, i.e., the physical confines of the room within which the MR scanner is located (see Appendix 3). Zone IV, by definition, will always be located within Zone III, as it is the MR magnet and its associated magnetic field that generates the existence of Zone III. Zone IV should also be demarcated and clearly marked as being potentially hazardous due to the presence of very strong magnetic fields. As part of the Zone IV site restriction, all MR installations should provide for direct visual observation by level 2 personnel to access pathways into Zone IV. By means of illustration only, the MR technologists would be able to directly observe and control, by means of line of site or by means of video monitors, the entrances or access corridors to Zone IV from their normal positions when stationed at their desks in the scan control room.
